# CASE STUDY

## Birds Blocked From Canopy With Bird Netting

**Location:** Tampa, FL

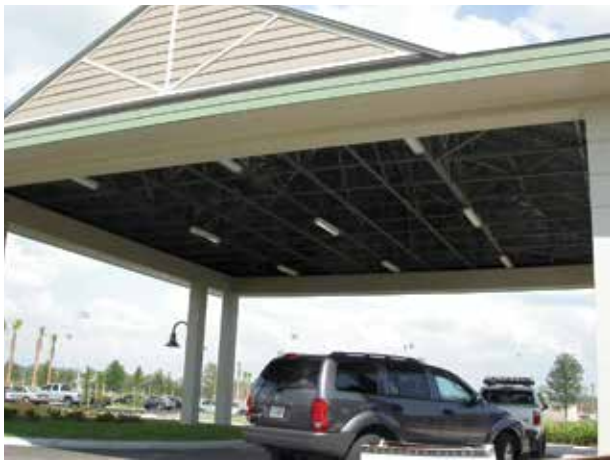
The bird netting becomes nearly invisible when installed.

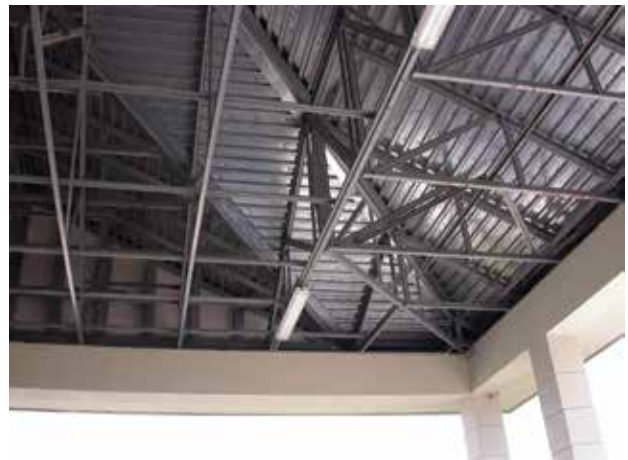
The outdoor canopy provided numerous beams, ledges, and lighting fixtures to roost on.

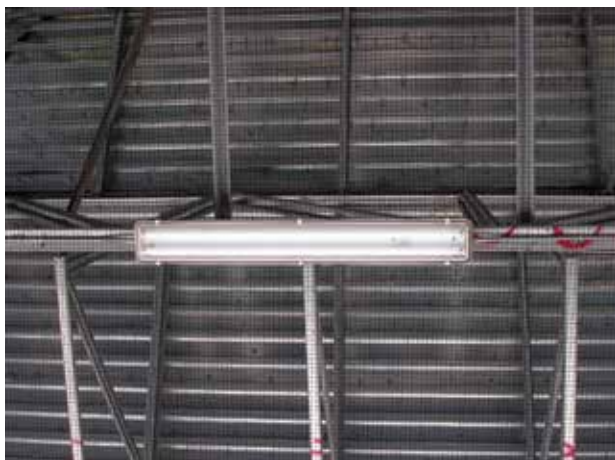
Bird Netting was wrapped around light fixtures to allow access.

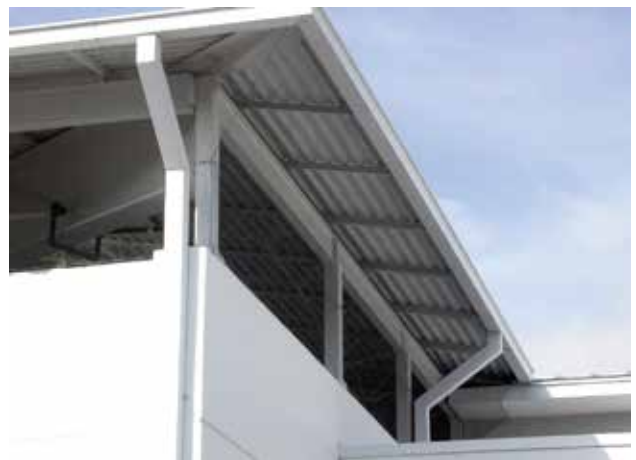
Netting was installed vertically along the backside to prevent birds from entering.
